## PROPERTY INSPECTION REPORT

**Concerning:** 2108 North 77th St, Millwood, PA 23884  
(Address or Other Identification of Inspected Property)

**By:** Joe Inspector December 22, 2005  
(Name of Inspector) (Date)

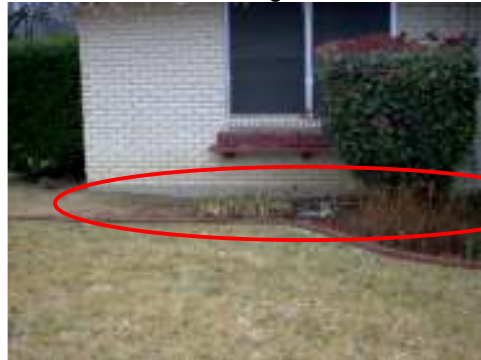
- Exterior: Area around patio in rear of house appears to be capable of pooling water. Though drainage appears to be sufficient on the day of the inspection, this location should be monitored and grading lowered to achieve flow away from the house.
- Exterior: Poor drainage on the front left side of the house. Water will pool here.

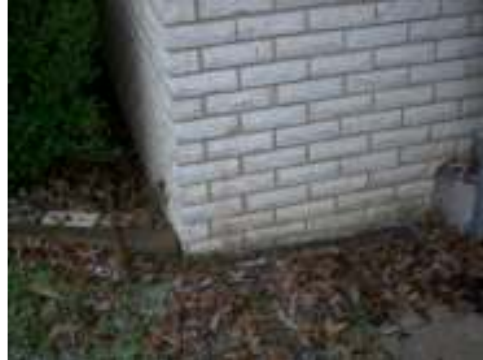
- Exterior: The soil line is high on the back side of the garage, conducive to termites.

Soil should be a minimum of 4" below foundation all around house to prevent water intrusion and insect infestation.

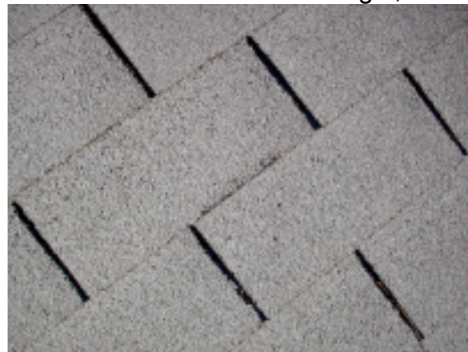
- Roof: Roof slope over front porch is too shallow for the covering materials used. No leaks apparent presently, but Inspector recommends monitoring this area periodically for leaks.
- Roof: Fasteners (nail heads) are exposed in several locations.
- Roof: Shingles are scuffed and/or damaged in several locations. Though damage is not extensive, Client should recognize that any damage decreases the effectiveness of the shingle, and shortens the life of the roof.

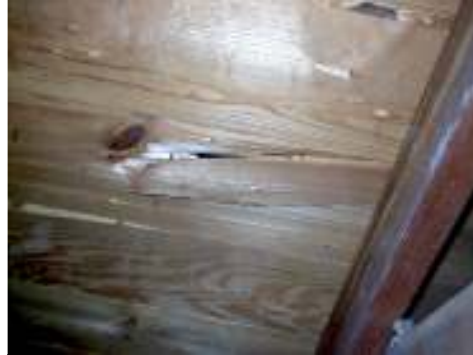
- Attic: Insulation has been torn away from duct above Kitchen ceiling.
- Attic: Observed broken decking board. See photo. No leaks observed at this location.

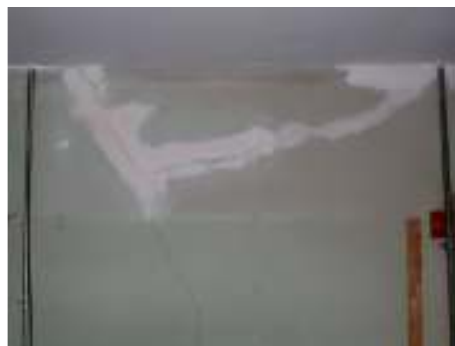
- Exterior: Observed stress cracks in brick and mortar at several locations (e.g., below and to the right of Dining Room window).
- Dining Room: Stress crack under window, roughly corresponds with location of crack in brick outside.
- Right Rear Bedroom: Drywall cracks are present in closet and above rear window.
- Garage: Drywall cracks are present on back wall and ceiling.

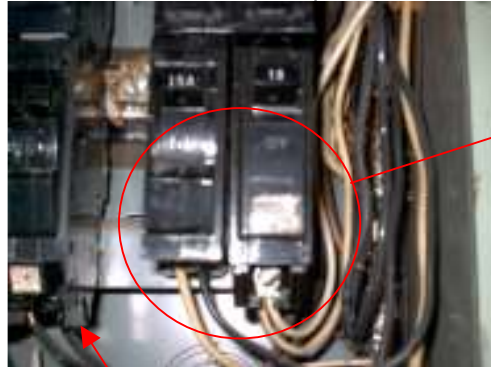
- Garage: Could not locate/confirm the presence of a grounding electrode for the electrical panel.
- Garage: Two 15-amp breaker(s) in lower right position are double fed. Recommend electrical specialist to evaluate and repair as needed.

These 2 breakers are not designed for two wire usage. Only one screw is present on each breaker. Recommend electrical specialist to evaluate and repair as needed.

These breakers are designed to allow two wire connections. Two screws are present on each breaker

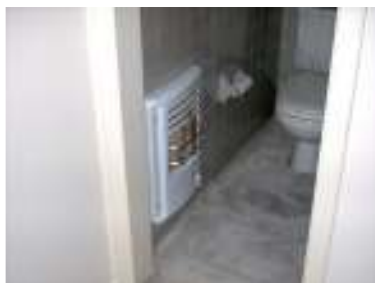
- Interior: The gas supply flex line is entering the furnace housing. Should be hard-metal pipe as it enters the furnace cabinet, in order to prevent rubbing and abrasion.
- Master Bathroom: Open-face (ventless) gas heater in use at this location.

Though these were in wide use when this house was built, current standards recognize inherent dangers from open flame, improper ventilation and carbon monoxide by-product. Inspector highly recommends removal of this unit and proper termination of the gas line BY A LICENSED PLUMBING SPECIALIST.
